## **FLIGHT TESTING THE TITANIC: RE-VISITING THE LOSS OF HIS MAJESTY'S AIRSHIP R.101**

**G B Gratton**

### **Abstract**

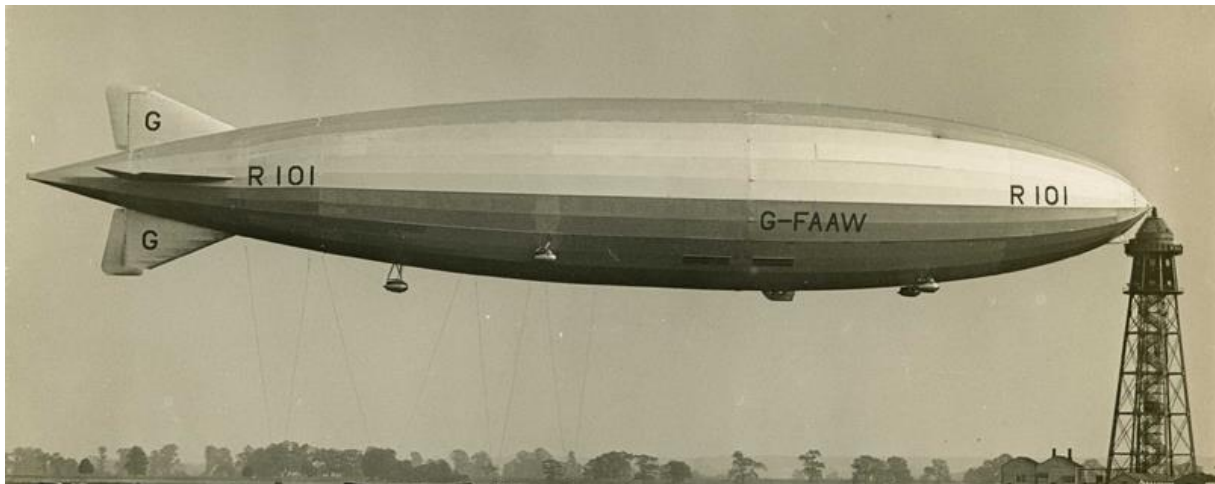
Figure 1 The R.101C airship on mast at Pulham

This paper is primarily about the events leading to the loss early on 5 October 1930 of the R.101 airship (Figure 1), which with a mass of about 150 tons and a volume in various modification states of 5,000,000 to 5,500,000 ft<sup>3</sup> was at the time the largest airship in the world, and remains one of the largest aircraft ever constructed. The aircraft was lost in a ground collision in France during the first leg of a planned 74 hour endurance flight to India.

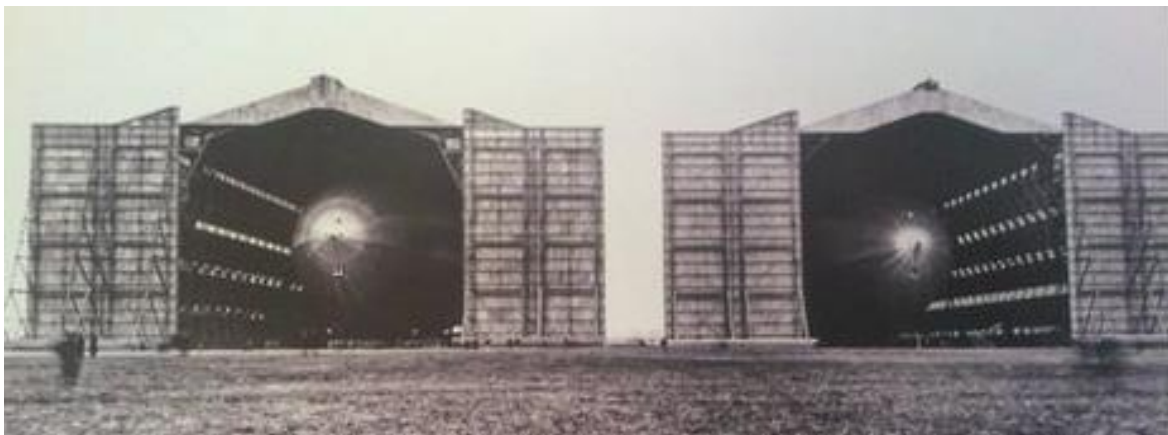
Figure 3 R.100 and R.101 airships in their sheds at Cardington: late 1929 or early 1930

By the end of 1929, both airships had flown: R.100, 12 hours<sup>(8)</sup> and R.101, 74 hours, and were installed in giant airship sheds dating from WW1 at RAF Cardington in Bedfordshire (these still stand and are in use in 2015 for a variety of purposes, including smaller modern airships)<sup>(9)</sup> (Figure 3). The R.33 had flown 800 hours, a number of these flights dedicated to science in support of R.100 and R.101 and reported back to both teams (although it appears that only R.101 staff had flown on board her, not R.100 staff<sup>(5)</sup>), as well as ensuring a cadre of highly experienced large airship flight testers, most of whom were Royal Air Force officers, available to both programmes. By this point 239 people had now crossed the Atlantic by airship with no unsuccessful crossing attempts, whilst of 27 crossing attempts by aeroplane, only 11 had succeeded, and 21 lives had been lost in the 16 failed attempts. So, the prescience of the 1924 Empire Airship Scheme, now managed again by Lord Thomson following the more secure return to power of the previously short lived Labour government under Prime Minister Ramsay MacDonald. Both airships were scheduled to continue testing through 1930.

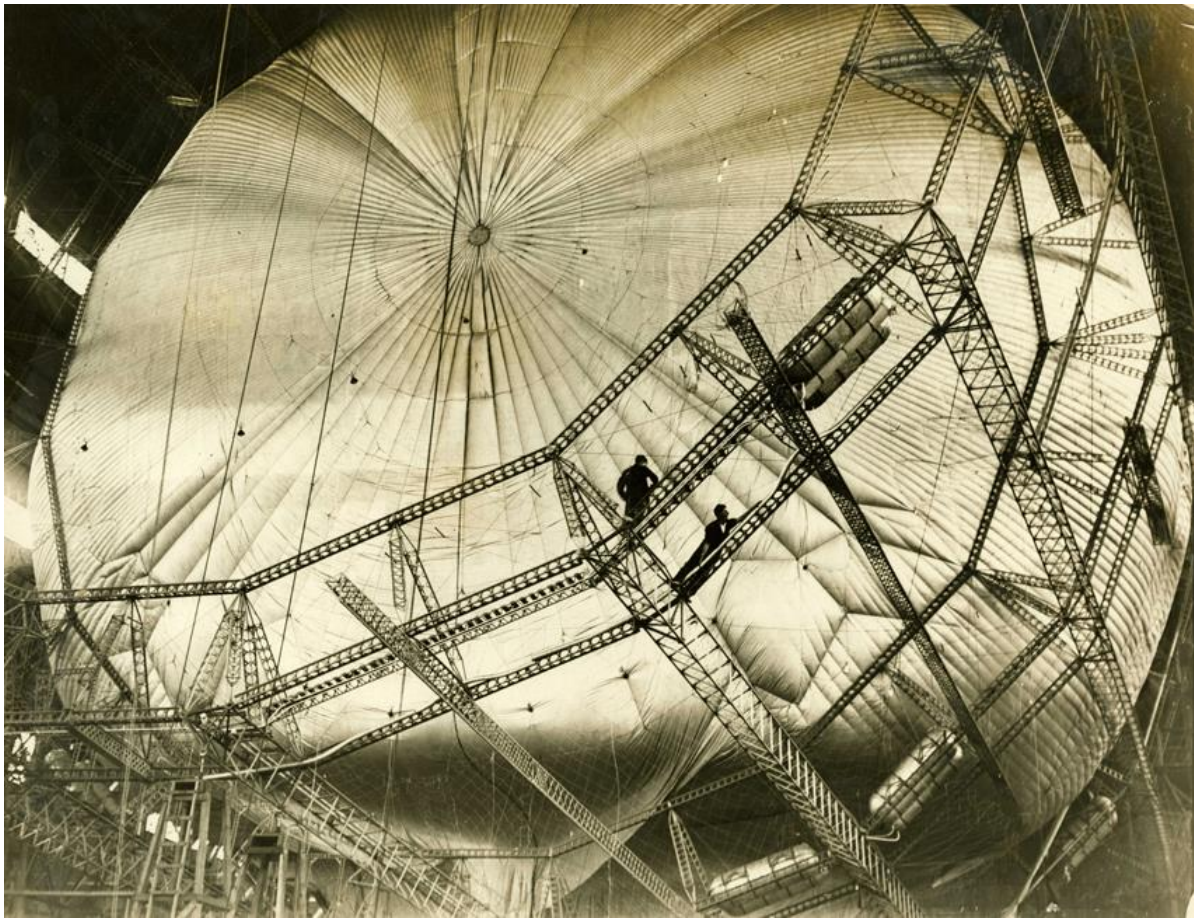
Figure 5 Gas bag within R.101 structure (the photograph shows a test bay mounted on the door of the airship shed at Cardington).

For the gas bags, both airships made extensive use of goldbeaters skin, a thin membrane material made from bullocks intestines<sup>(15)</sup>. This had been a major strategic material for Germany during WW1, to the point that the occupied territories in Poland, Austria and northern France had been banned from making sausages so that the skins were available for Zeppelin manufacture. In Britain, goldbeater's skin had been used to make the gas bags of balloons for the Royal Engineers at Chatham from 1881–82<sup>(16)</sup>. Different techniques were used on the two airships for restraining and transferring loads from the giant hydrogen bags – but in the R.101 particularly there was a very major problem with chafing, leading to leaks in the R.101B configuration (see below) in the order of 50-90,000 ft<sup>3</sup>/day, and even in the last R.101C configuration of 20-30,000 ft<sup>3</sup>/day. There were fears that leaking hydrogen had the potential to pool within the top of envelope, amplifying any pitching motion, and holes around the nose were provided to ventilate the area and reduce potential for hydrogen pooling.

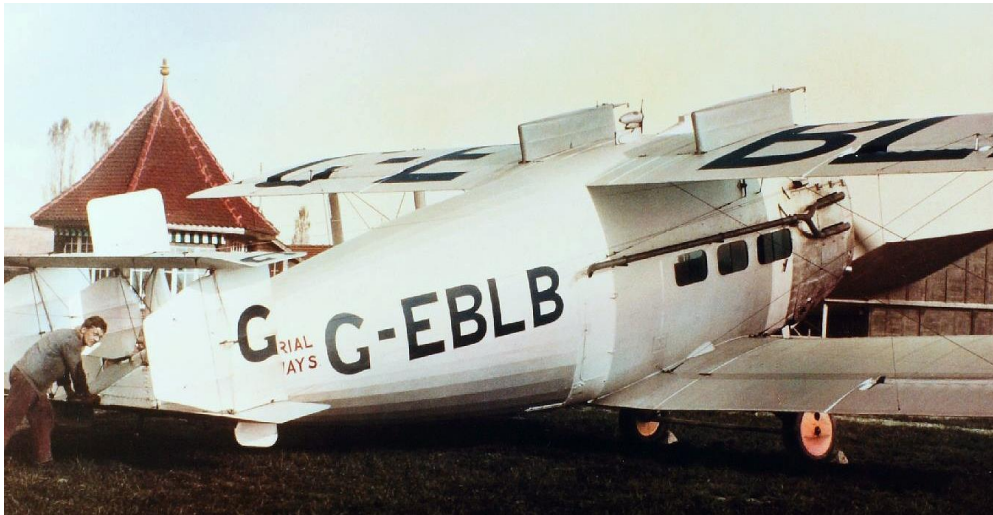
Figure 8 Imperial Airways Vickers Vulcan G-EBLB before its accident

A very much more recent event at the time was the loss of Imperial Airways' Vickers Vulcan airliner G-EBLB (Figure 8) from Croydon aerodrome on 13 July 1928<sup>(19, 20, 21)</sup>. This had been a post maintenance air test during which the engine failed a few minutes after take-off, resulting in a forced landing and fire. Four airline employees, flying on a "joyride" were killed, one in the impact and three in the post-crash fire – only the pilot and one passenger surviving. The coroner's report into this recommended that the carriage of passengers on test flights should cease<sup>(22, 23, 24)</sup>; this recommendation was accepted by the state owned Imperial Airways.
